**Container Loading Supervision Report**

<b>Conclusion:</b>	<b>FAIL</b>
--------------------	-------------

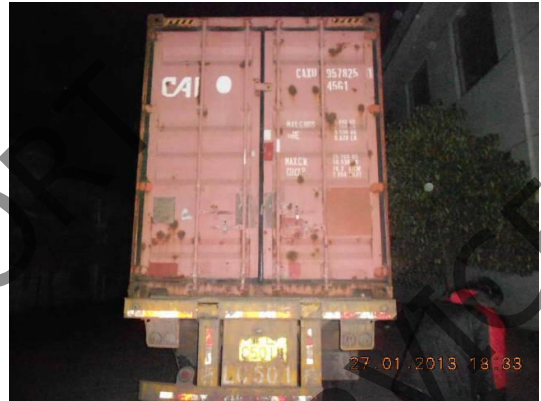
Inspection summary:		
Inspection Sections	Conform? (Y/N)	On-site Findings/Comments
1. Quantity & Assortment	Y	
2. Condition of container(s)	Y	
3. Condition of export cartons	Y	
4. Random quality "spot-check"	Y	
5. Shipping marks	N	Shipping mark doesn't match the client's requirement
6. Loading process	Y	
7. Container details	Y

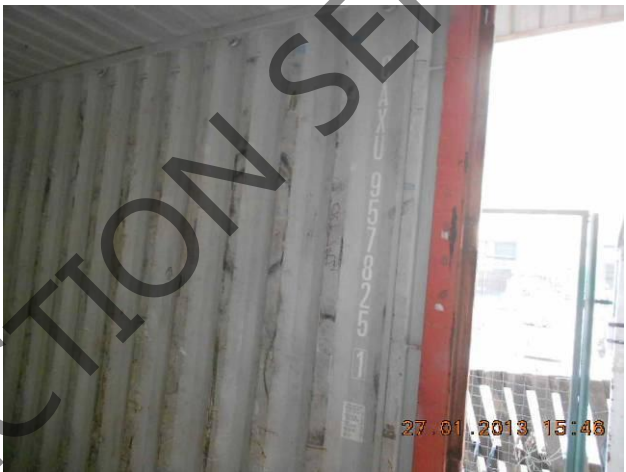
3. Condition of export cartons:	
×	<b>PASS:</b> Dry and in good working condition, free from serious damage, suitable for holding and protecting the said cargo, properly palletized
	<b>FAIL:</b> Crushed, with large holes, containing other serious damage, not suitable for holding and protecting the said cargo, improperly palletized
	<b>Other:</b>

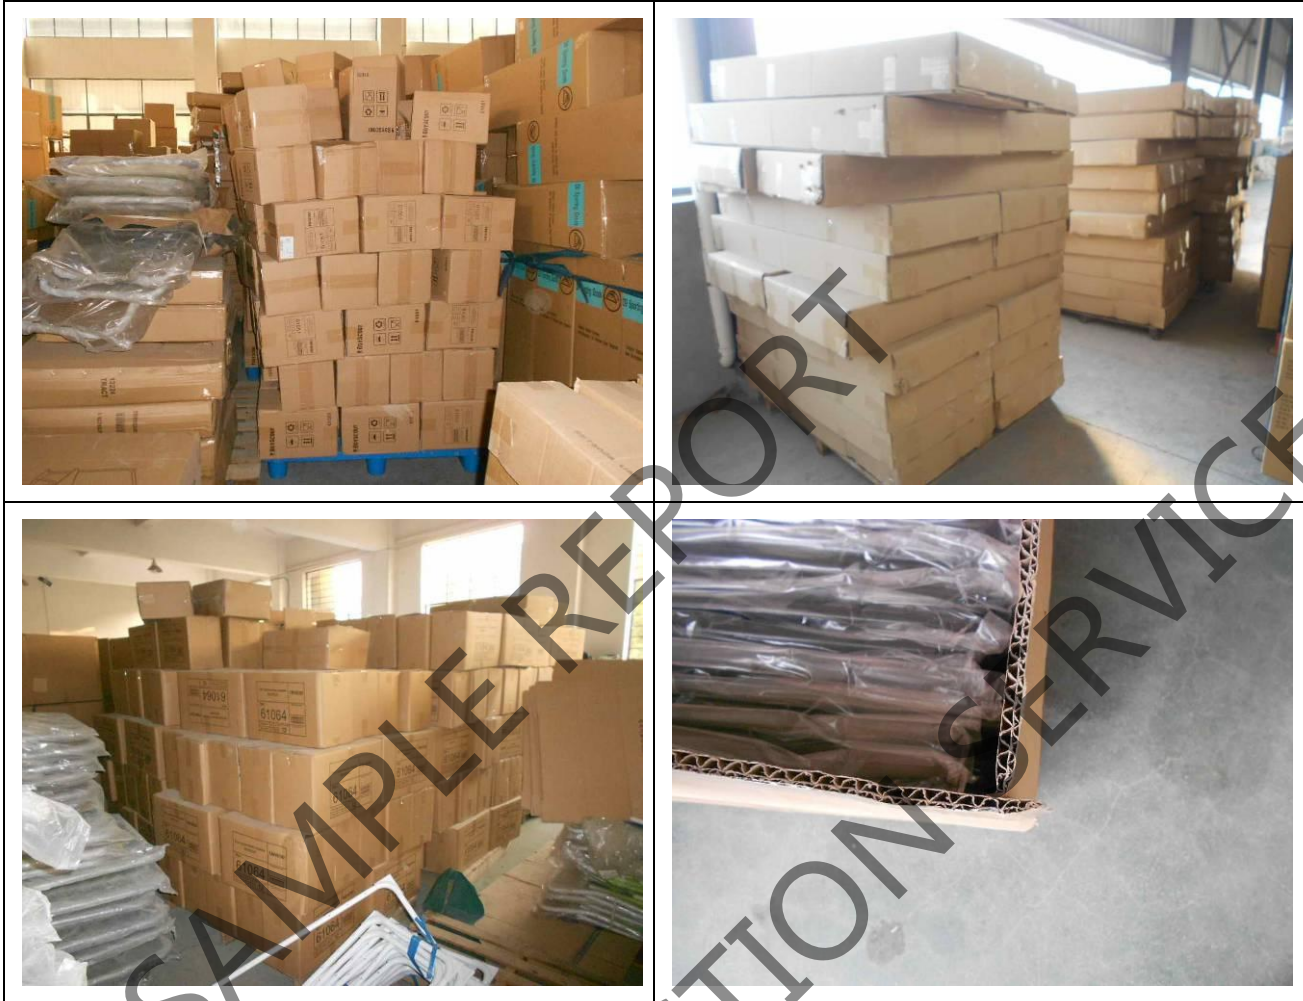
4. Random quality "spot-check":			
#	Checking item description	Conform? (Y / N)	On-site Findings/Comments
4.1	Randomly draw cartons and visually inspect the products inside them. Also inspect the function if possible and record down the findings	Y	No found major defect
