Pre-shipment Inspection Report

General Information:	
Report Number:	N/A
Product name:	Wall clock
Item #:	170092070#
PO#	36006678#
Ordered quantity:	900PCS
Client name:	N/A
Supplier name:	Zhangzhou XXXX Electronics Trading Co., Ltd.
Inspection Date:	Feb-27-2014
Departure time to the factory:	8:00AM
Arrival time:	10:00AM
Departure time:	16:00PM
Inspection location:	Zhangzhou Fujian China

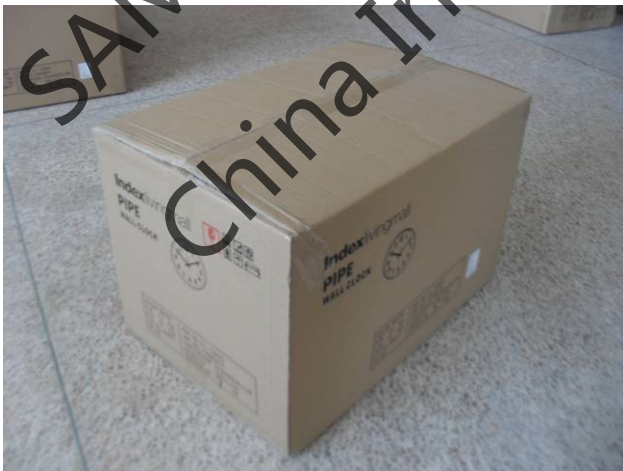
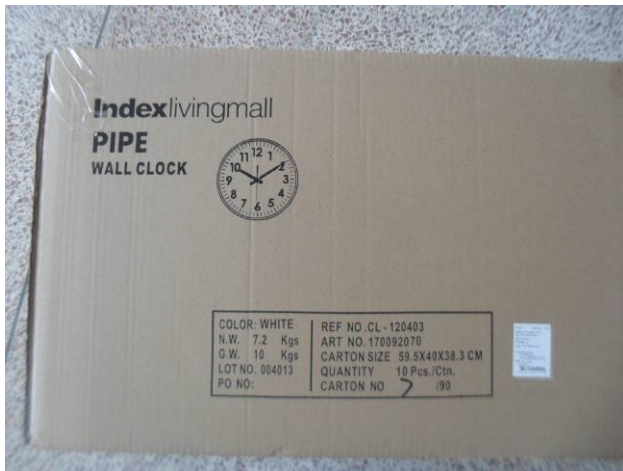
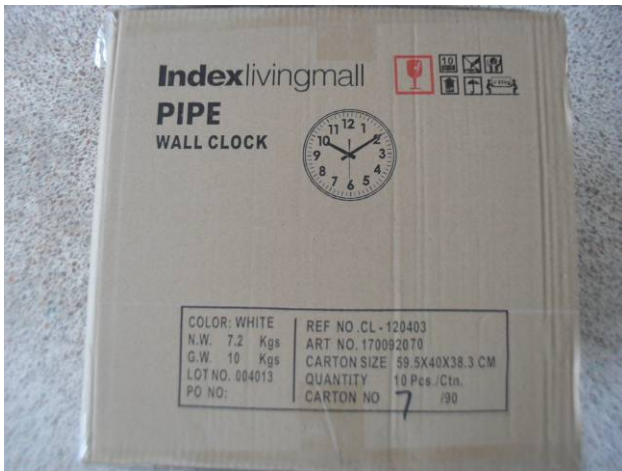
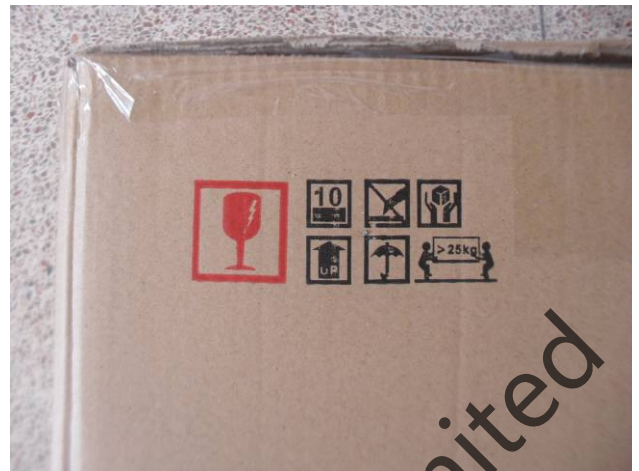
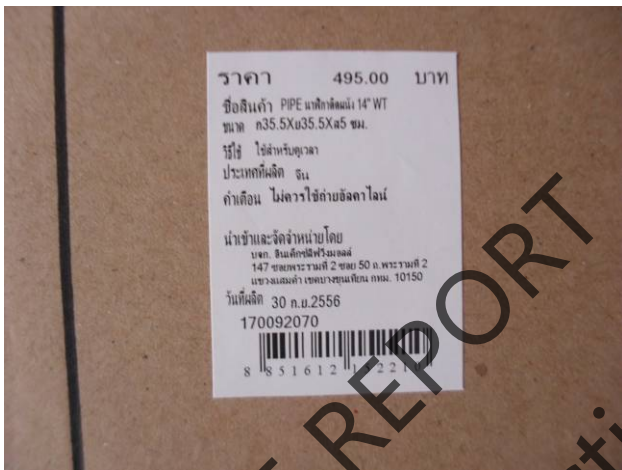
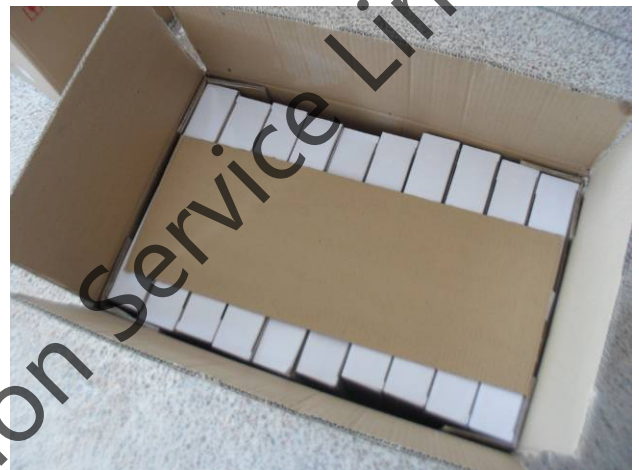
Pictures:

2. Packing inspection:			
Test #	Spec Requirement	Conform? (Y / N / PENDING)	Remarks
2.1	Packing method checking	Y	See the below pictures
2.2	Shipping mark checking	Y	See the below pictures
2.3	Carton dimension checking	Y	See the below pictures
2.4	G.W. checking	Y	See the below pictures
2.5	Carton material checking	Y	See the below pictures
2.6	Product Manual (included in packing?)	N	N/A
2.7	Warranty card (included in packing?)	N	N/A

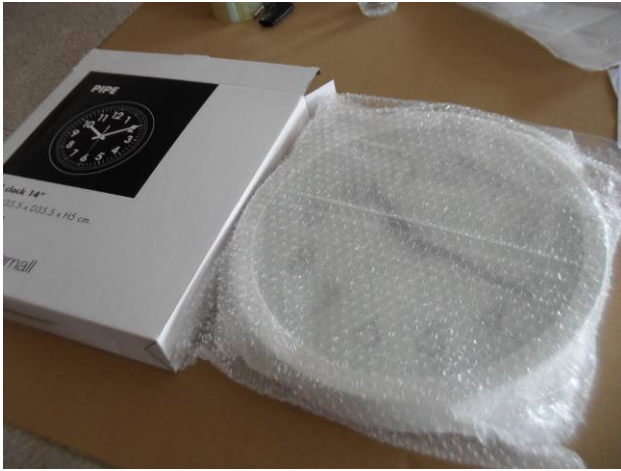
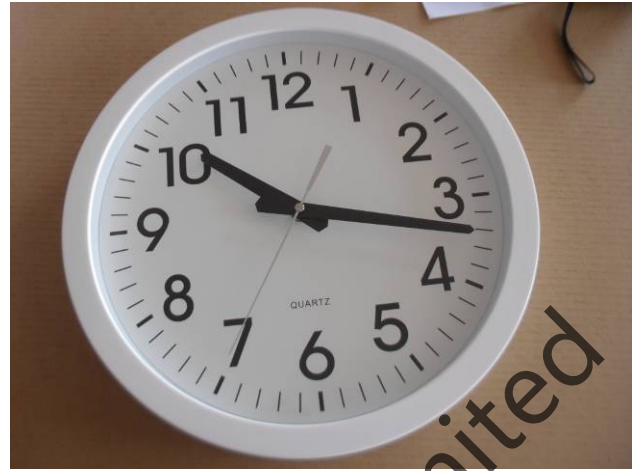
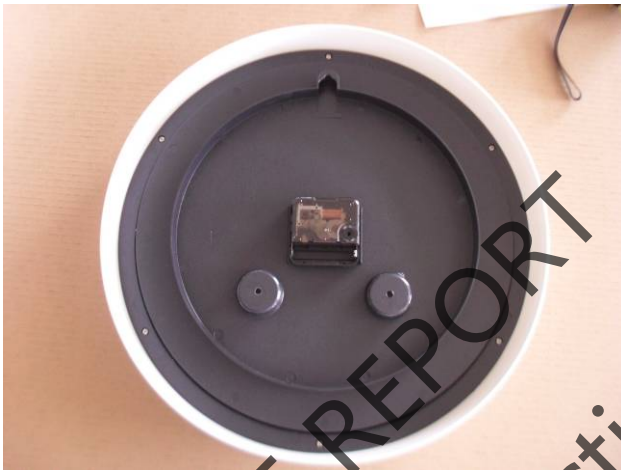
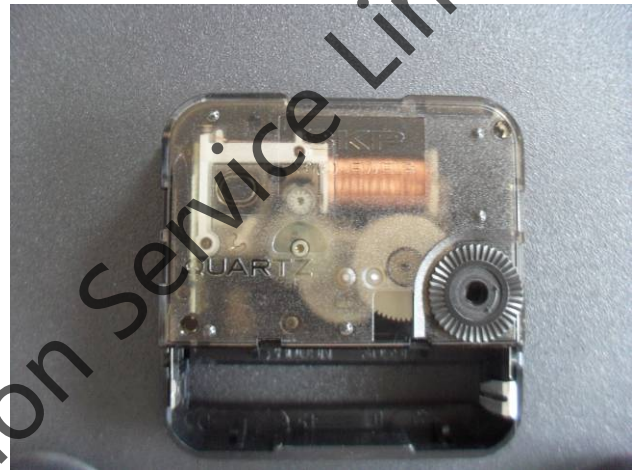
Pictures:

3. Product conformity inspection:			
Test #	Testing Items	Conform? (Y / N/ PENDING)	Remarks
3.1	Product style	Y	See the below pictures
3.2	Product color	Y	See the below pictures
3.3	Product description	Y	See the below pictures

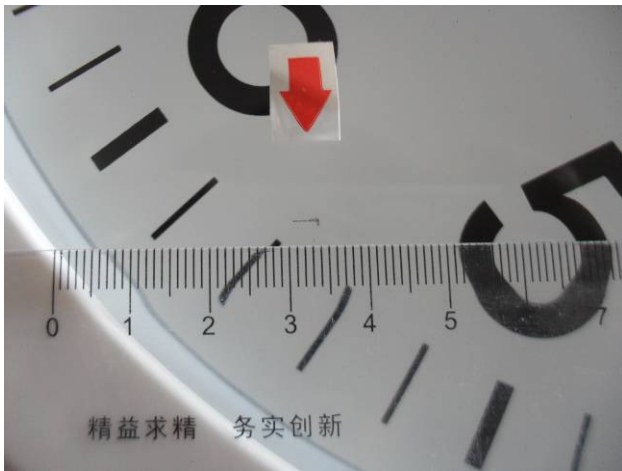
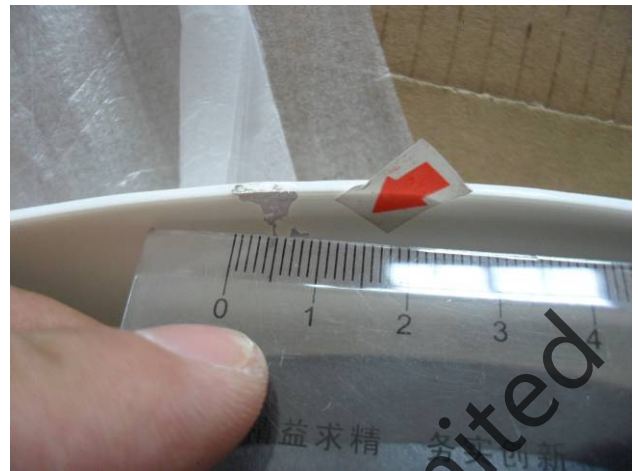
Pictures:

4. Workmanship appearance / function inspection					
#	Defect description	Cri.	Maj.	Min.	Remarks
170092070#	Dirty mark on the glass			1	
	Dirty mark on the case			1	
Total defects:				2	
Maximum allowed defects:		0	5	7

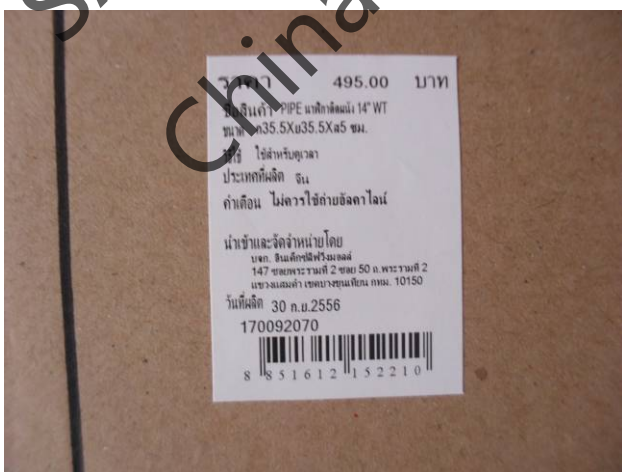
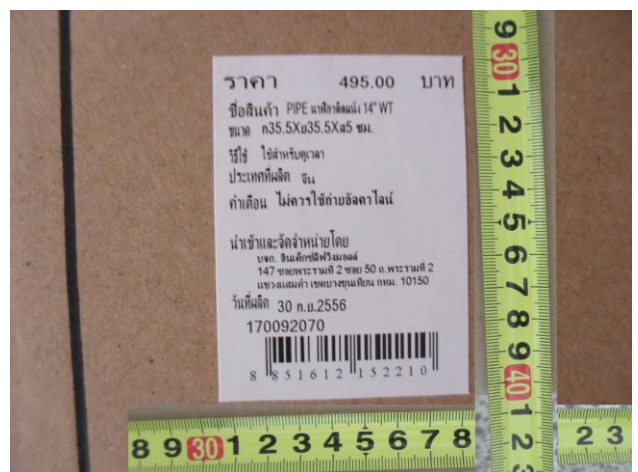
Pictures:

5. Bar code / label inspection			
#	Defect description	Conform? (Y / N/ PENDING)	Remarks
5.1	Bar code	Y	Barcode NO. 8851612152210
5.2	Care/composition label (washing notification)	N	N/A
5.3	Size label	Y	Same as client require
5.4	Country origin label	N	N/A
5.5	Hang tag	N	N/A
5.6	Poly bag printing / label	Y	Same as client require
5.7	Aging grade label	N	N/A
5.8	Small part warning label	N	N/A
5.9	Sharp point/sharp edge warning label	N	N/A

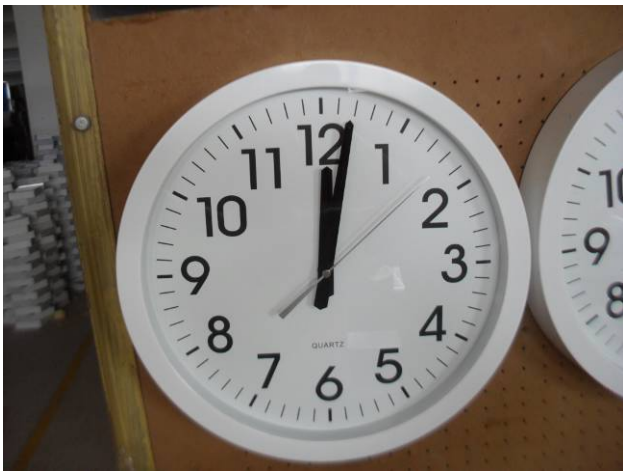
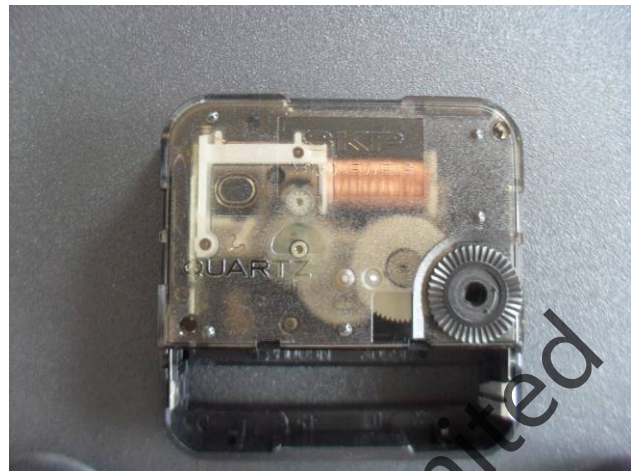
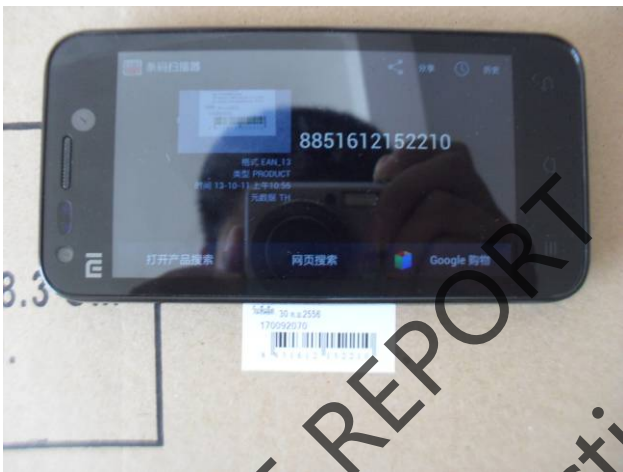
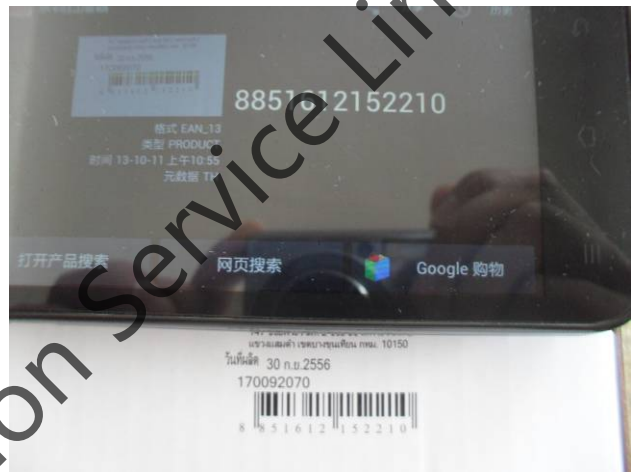
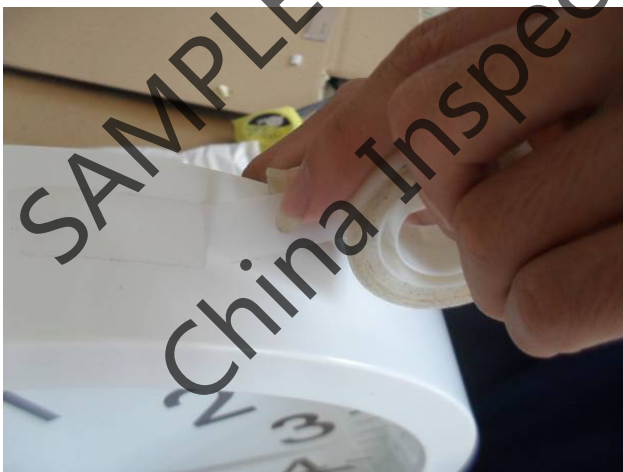
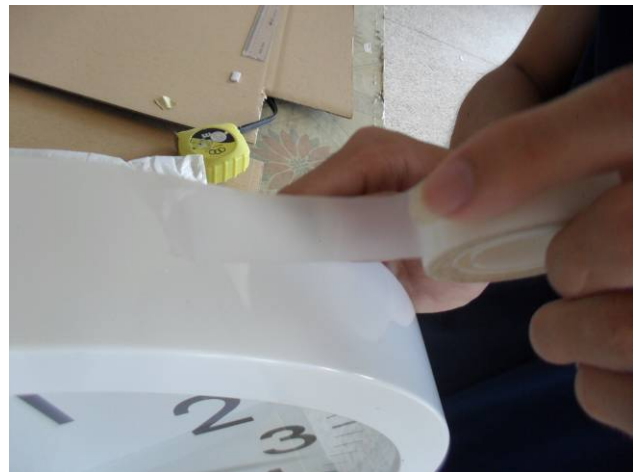
6. Reliability & Function tests				
#	Testing Items	Sample Size	PASS/FAIL	Defect Description
6.1	Carton Drop test	0	Pending	
6.2	Assembly test	7	Pass	0
6.3	Disassembly test	7	Pass	0
6.4	Barcode scanned test	2	Pass	0
6.5	3m tape test	5	Pass	0
6.6	Fitting test	5	Pass	0
6.7	Function test	5	Pass	0
6.8	Hanging test	5	Pass	0
6.9	Accuracy test & Current test	2	Pass	0

Remark : Factory not allow to carton drop test .

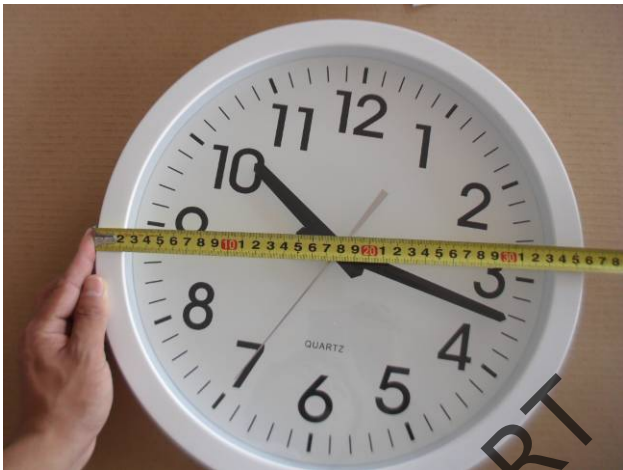
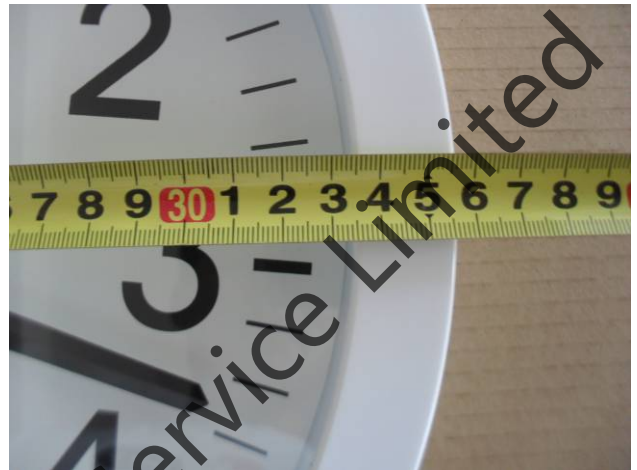
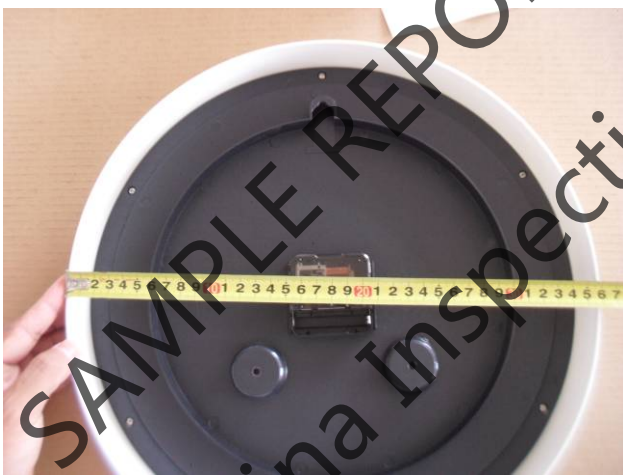
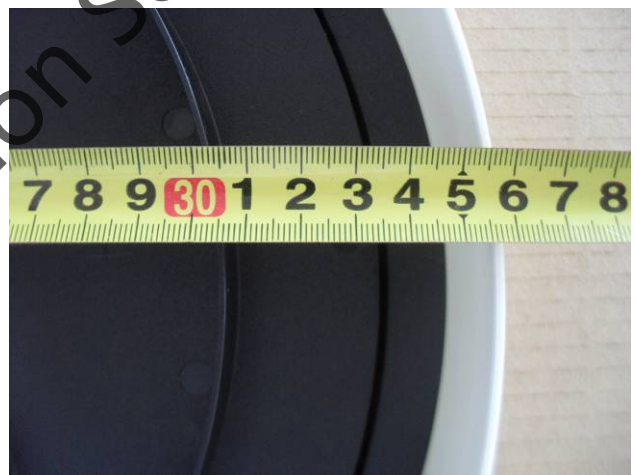
Pictures:

Test #	Testing items	Spec.	Sample #				
			1	2	3	4	5
170092070#	Product size	35.5x35.5x5cm	35.5x35.	35.5x35.	35.5x35.	35.5x35.	35.5x35.

5x5cm	5x5cm	5x5cm	5x5cm	5x5cm
	Inner box size	N/A	36x36x5 .5cm	36x36x5 .5cm	36x36x5 .5cm	36x36x5 .5cm	36x36x5 .5cm
	Carton size	57.5x38x38cm	60x40x3 9cm	60x40x3 9cm	60x40x3 9cm	60x40x3 9cm	60x40x3 9cm
